## MPW Pioneers Cleaning Application to Improve Coke Battery Efficiencies

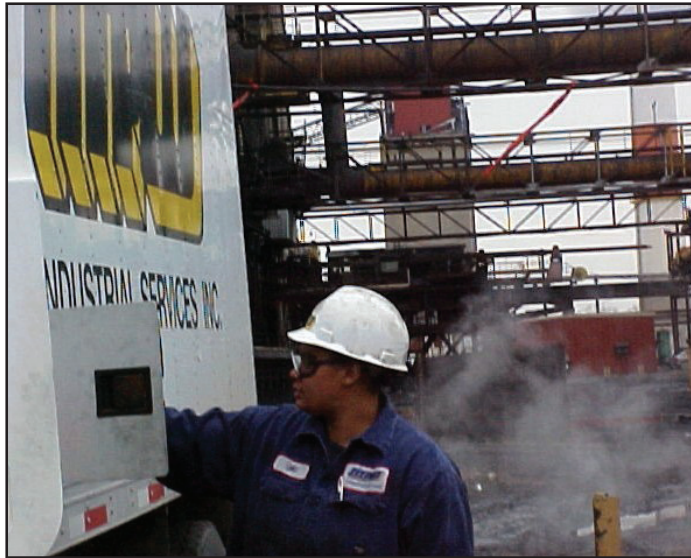
*MPW Operator adjusts gauges on-site during underfire gas line cleaning at a steel mill. Seven MPW technicians were trained in the unique cleaning procedure used to remove the obstructions. Pressurized containment basins were used to capture materials removed from the underfire gas line.*

After several plan revisions, MPW suggested installing valved hot taps on the gas lines, thereby creating an access point for a waterblasting lance. The dislodged material was removed via a drop leg into a containment basin. Maintaining a constant positive pressure with the water seal was critical to the success of this innovative cleaning technique because it prevented further contamination.

MPW technicians designed and fabricated a 10,000 p.s.i. waterblasting tool used in conjunction with wet/dry vacuuming equipment to remove the hardened material from the lines. MPW personnel then transferred the waste slurry into porous geotubes, allowing the waste water to drain into a containment area where it was processed.

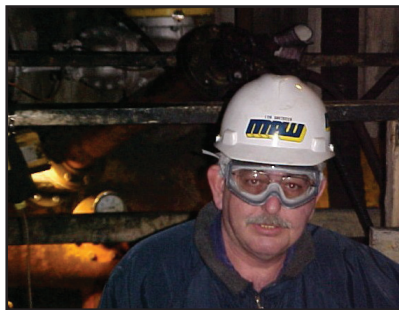
*MPW Operations Manager Lonnie Davidson inspects the underfire gas line cleaning apparatus. Davidson was a member of the MPW team that developed the unique cleaning application.*
